USAAVLABS TECHNICAL REPORT 66-55

DIAGNOSTIC NOISE STUDY OF POWER TRANSMISSION SYSTEMS

Final Report

CONTRACT DA 44-177-AMC-249(T)
CURTISS-WRIGHT CORPORATION
CALDWELL, NEW JERSEY

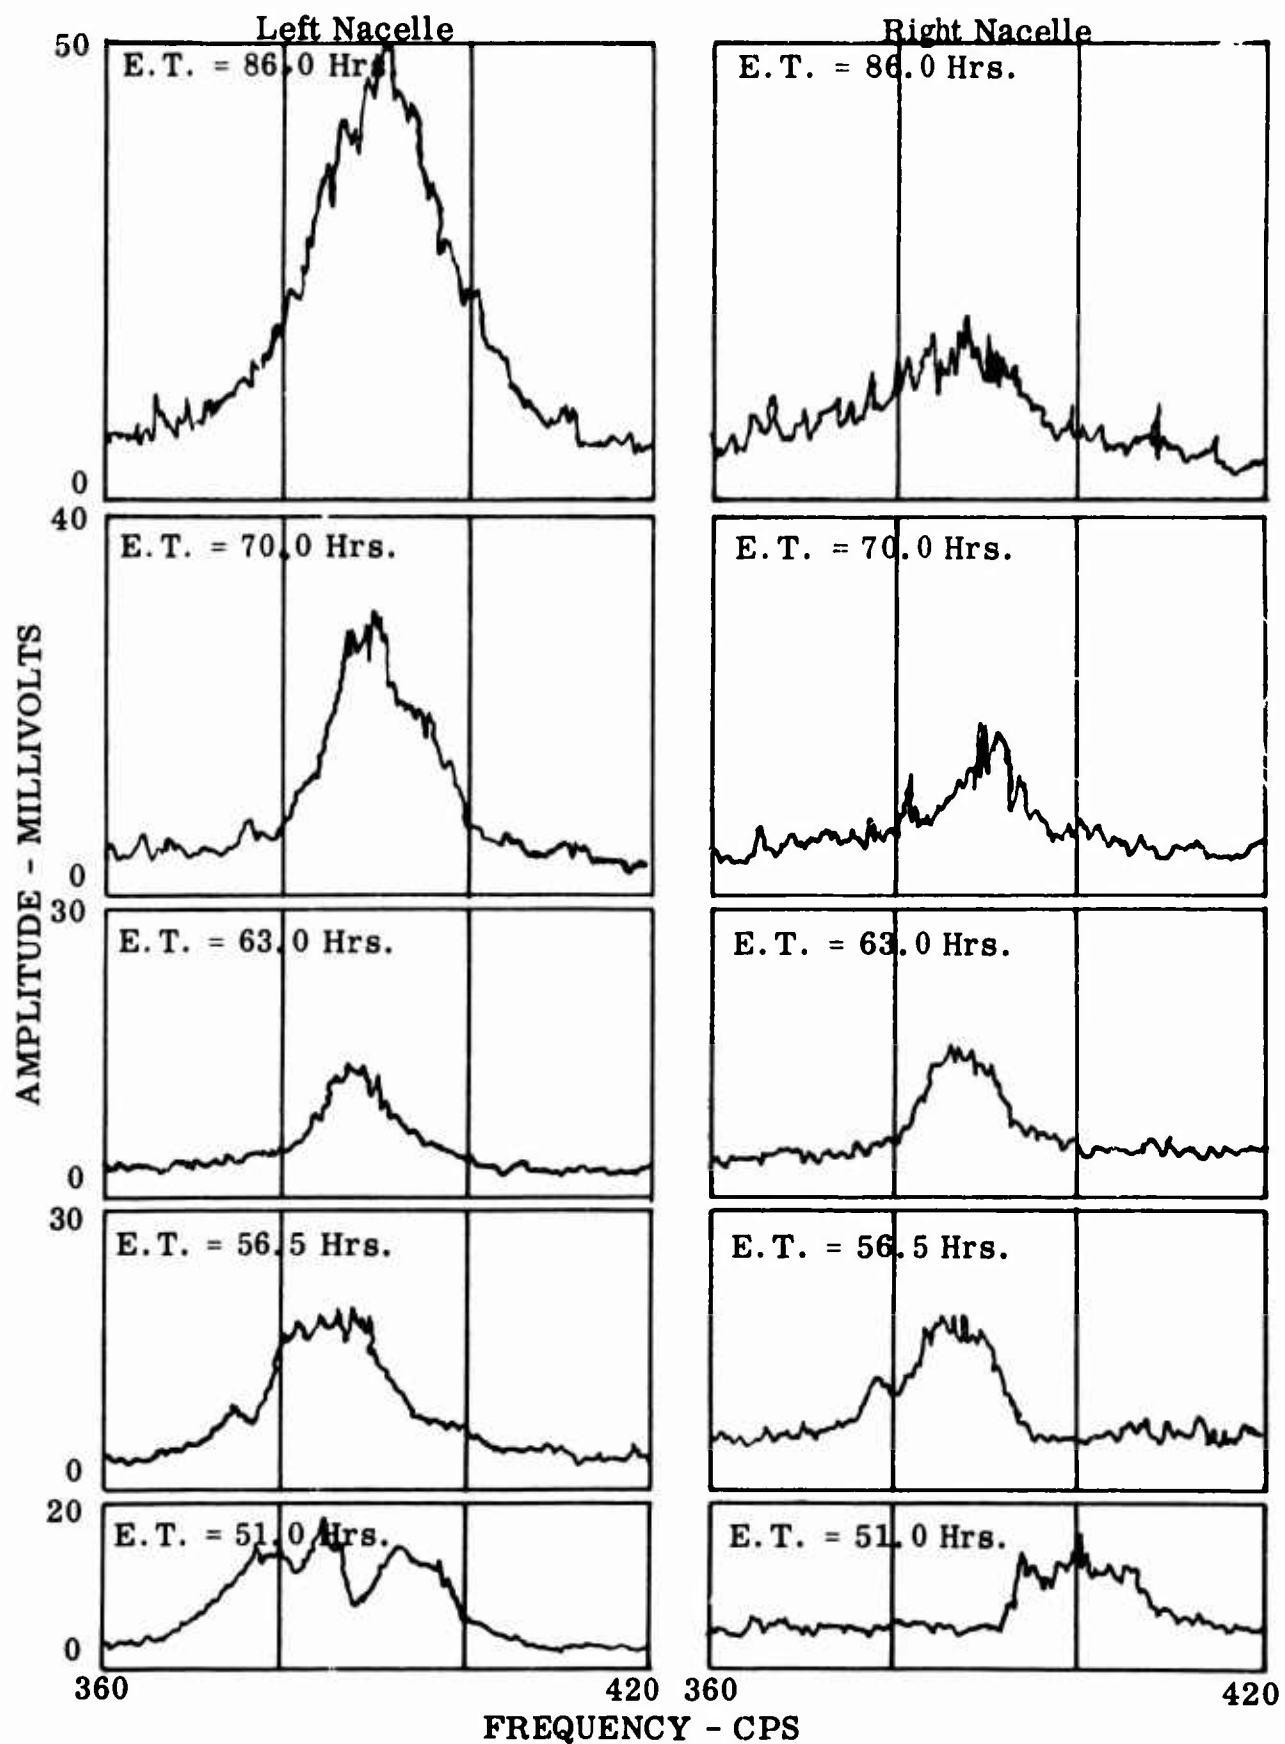
63 hours of endurance. At both 63 and 86 hours of endurance (Figure 27), the amplitude of the nacelle gear and bearing frequency has increased progressively along with an increased iron content, as shown in Figure 11. A visual inspection revealed a spalled roller on the left nacelle No. 1 bearing and marked bevel gears. A photograph of this spalled bearing is shown in Figure 29. No scuffing or pitting was evident. Unfortunately, no recordings were taken at "idle" RPM after 86 hours of endurance due to the cessation of testing because of contract termination. Consequently, at the maximum iron content shown in Figure 11 at 91:45 hours of endurance, there is no corresponding acoustic spectrogram.

Figure 27. Amplitude vs. Frequency Spectrograms of the Nacelle Bevel Gear and No. 1 Pinion Bearing at Various Time Intervals

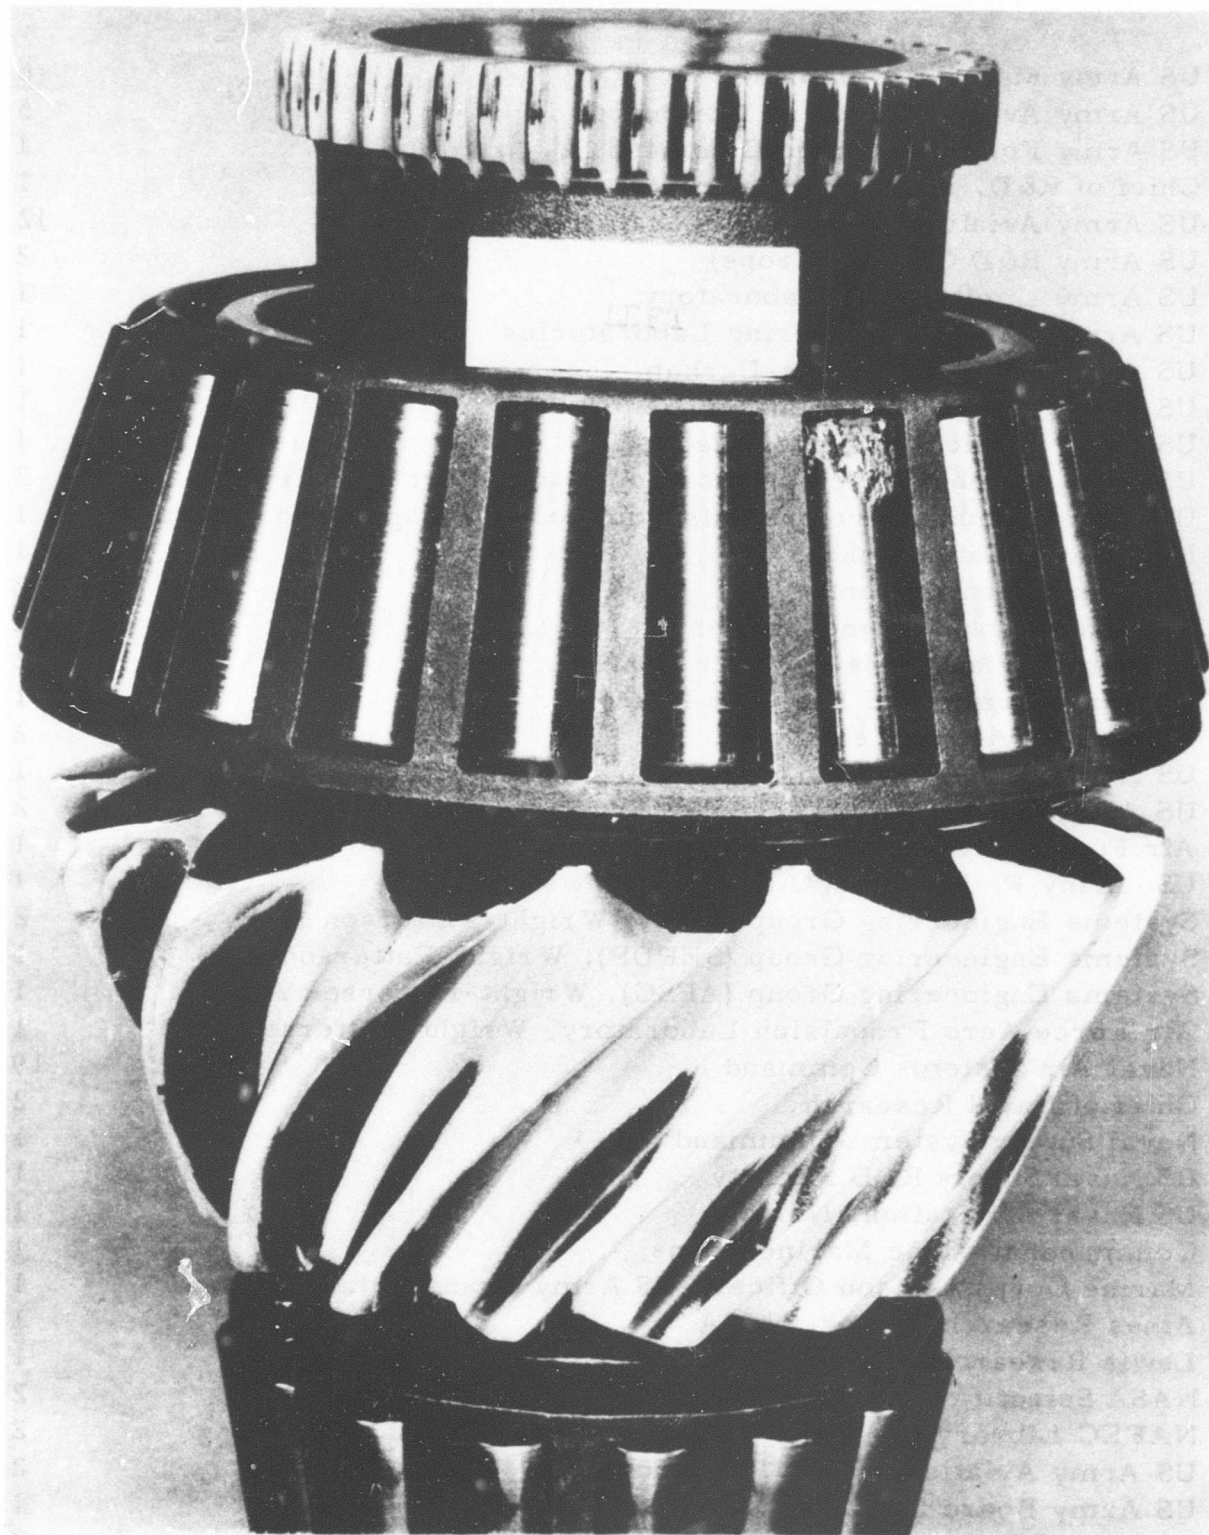
Excellent correlation between acoustic and spectrometric oil analysis was achieved during the last 41:45 hours of endurance as a result of a spalled roller in the left nacelle No. 1 pinion bearing. Other failures showed little or no correlation between the two techniques, possibly due to the nature of the failure, as explained under Sections IV-B and -D of this report.

Figure 29. Left Nacelle No. 1 Pinion Bearing Showing Spalled Roller
